NATIONAL BUREAU OF STANDARDS REPORT

INVESTIGATION OF THE DIRECTIONAL EFFECTS IN THE STRESS CORROSION OF ALUMINUM ALLOYS

Final Report

April 22, 1968

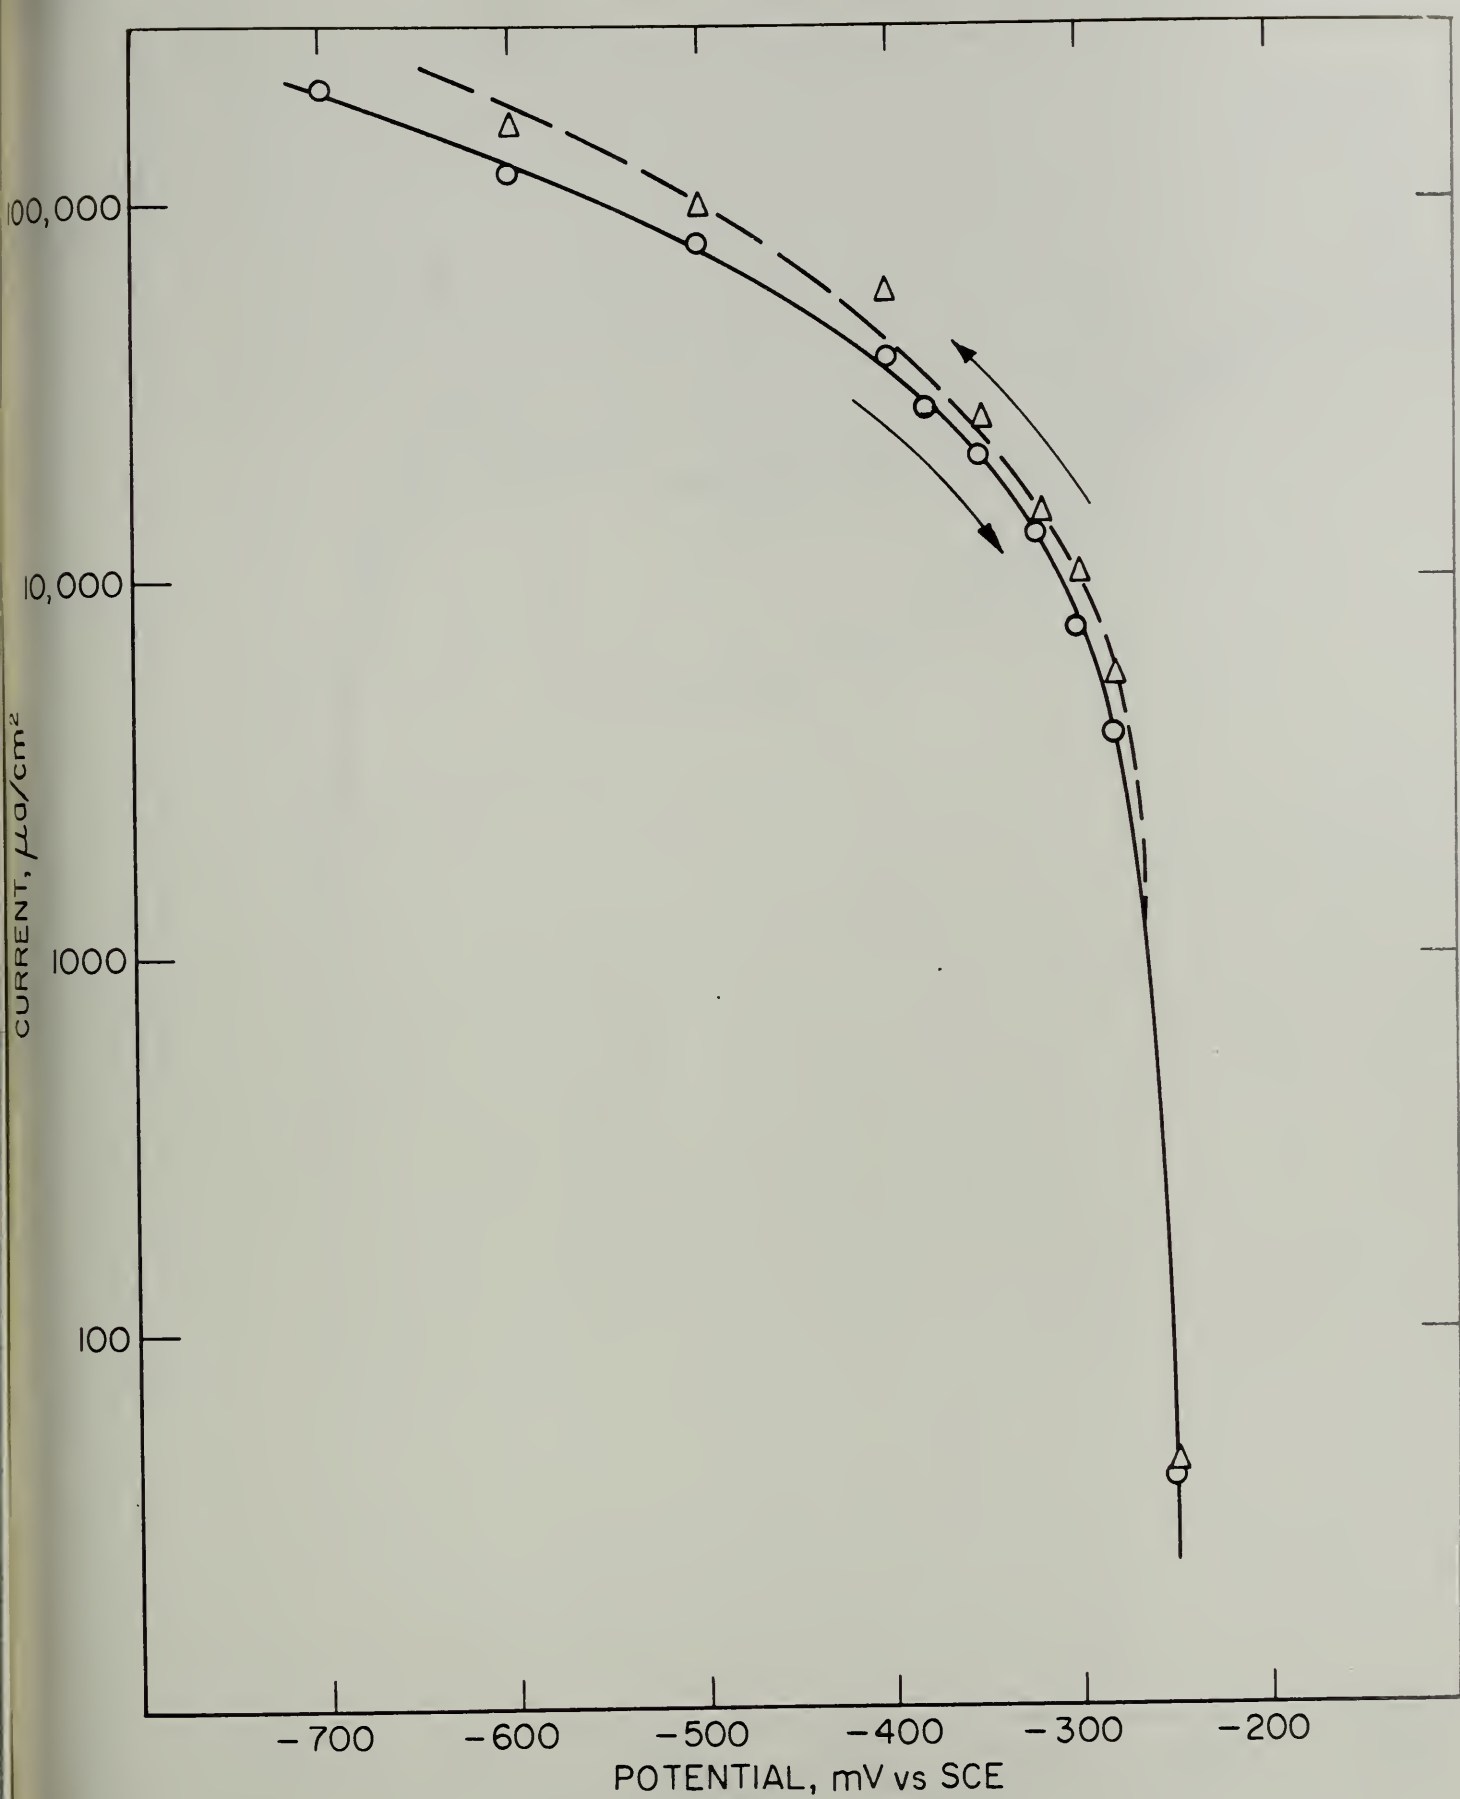
FIGURE 46

Cathodic polarization curve for 7075-T651 in 1.0N NaNO₃
(pH = 0.9 with HNO₃). Open circuit EMF = -260 mV vs SCE.

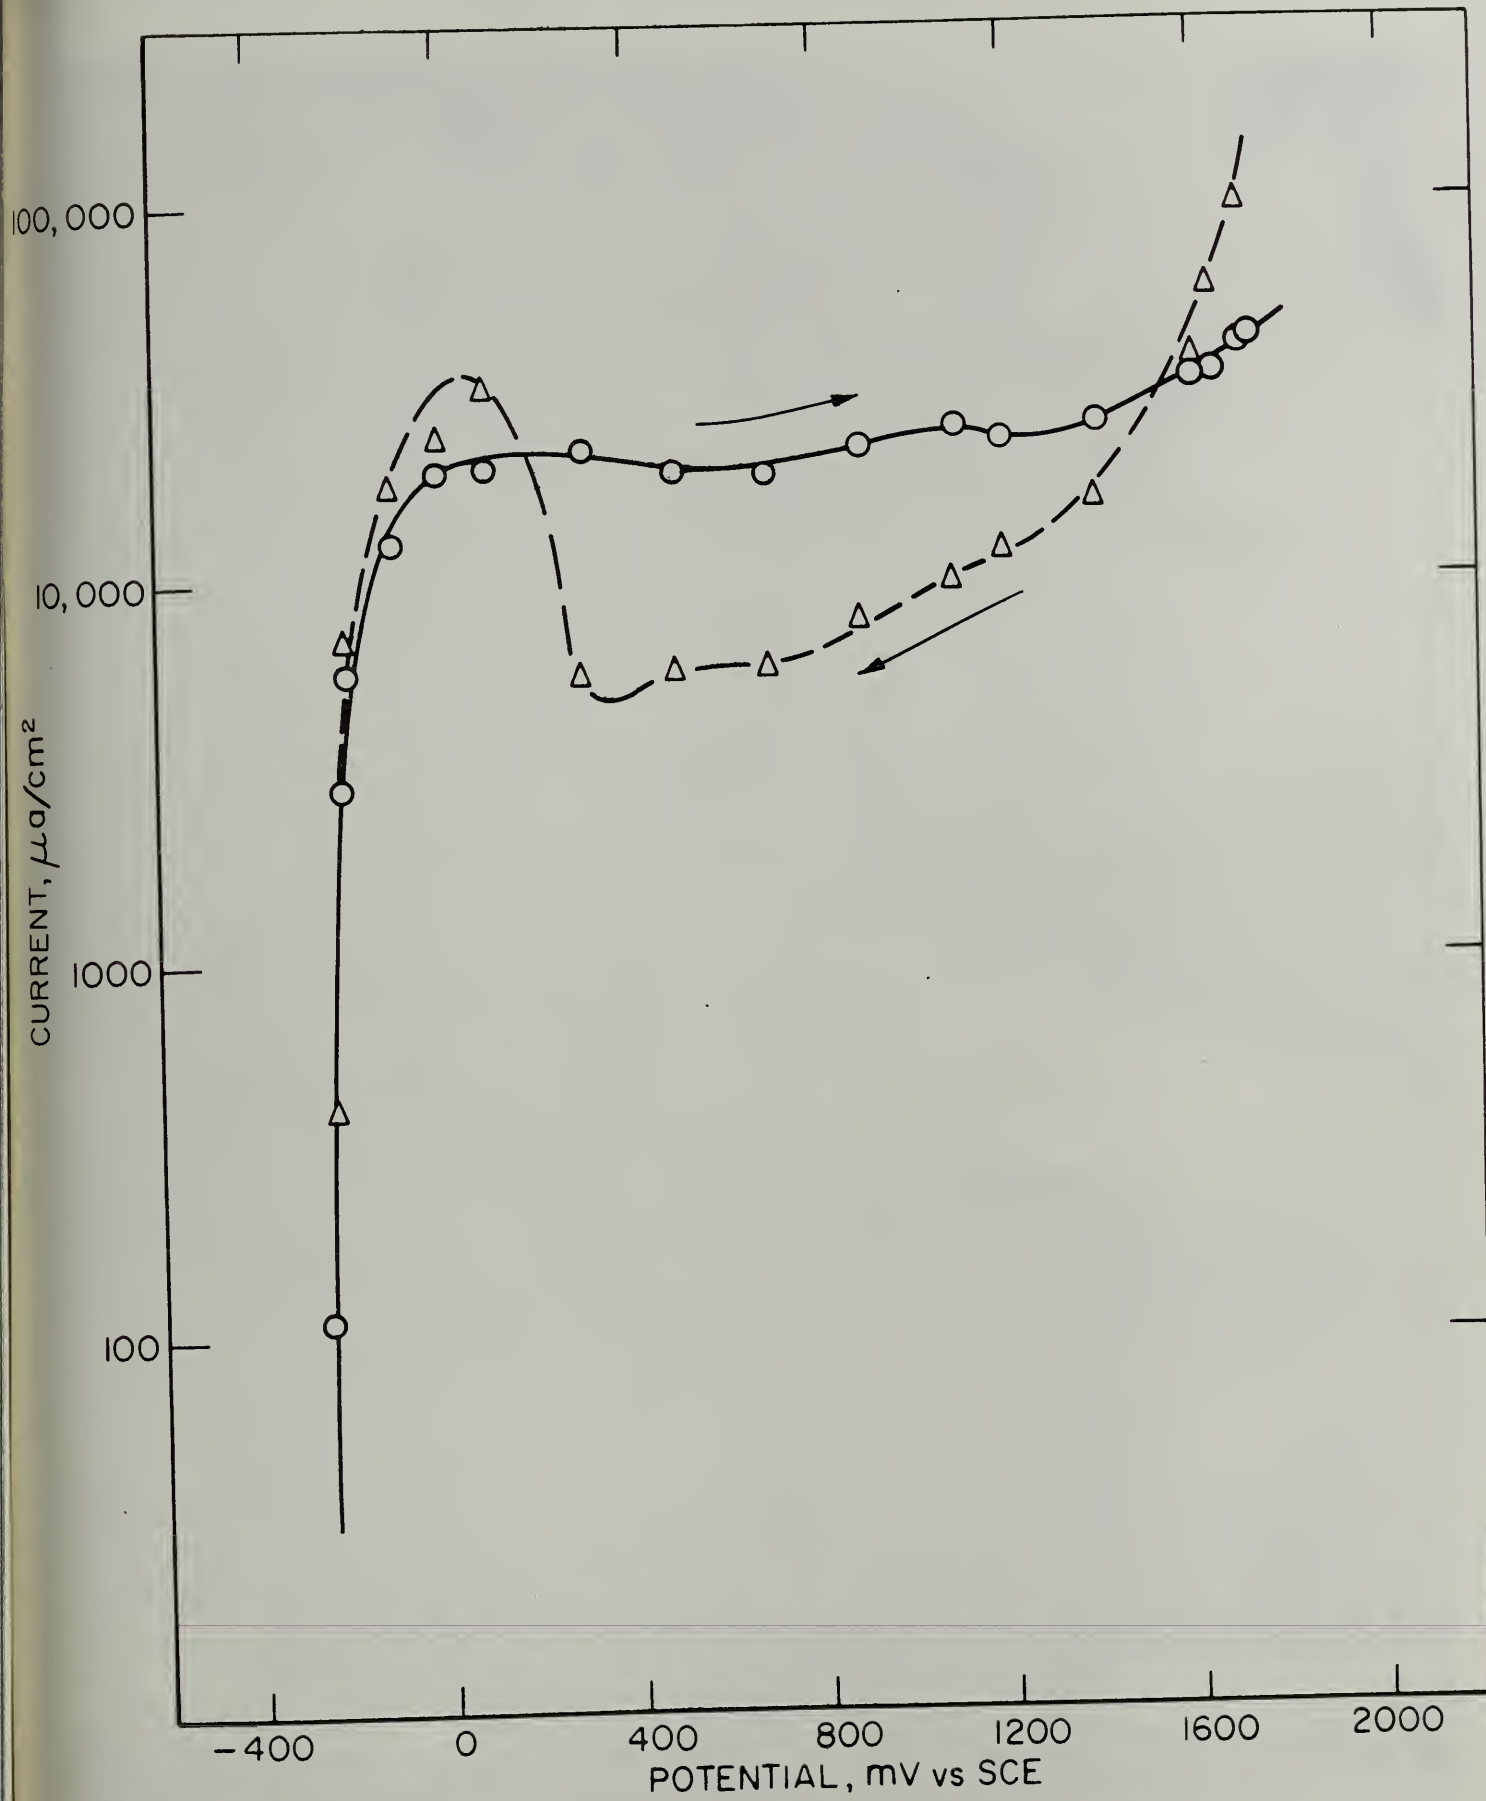
FIGURE 47

Anodic polarization curve for 7075-T651 in 1.0N NaNO_3
(pH = 0.9 with HNO_3).

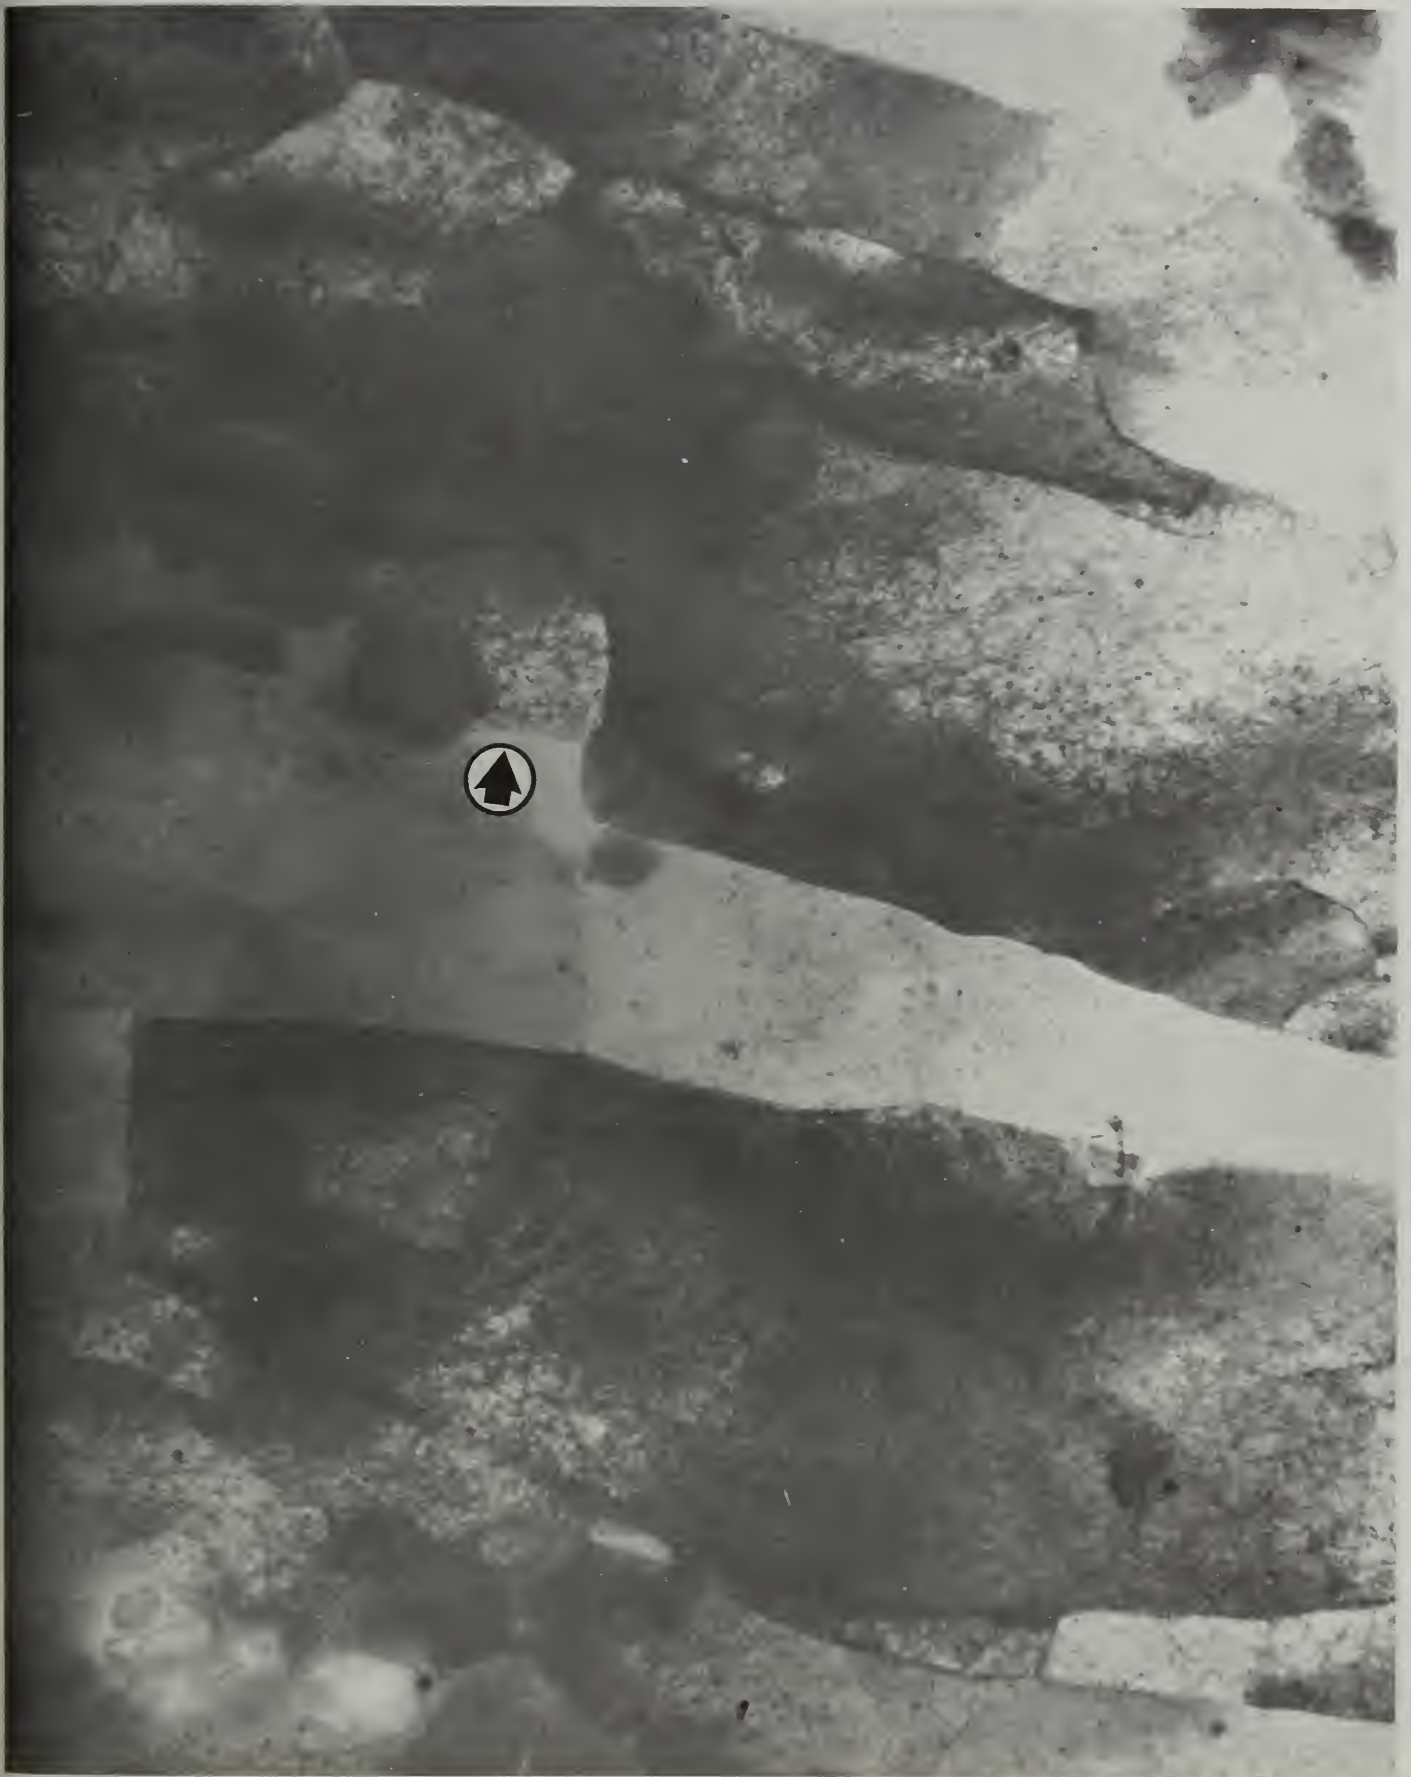
FIGURE 48

Grain morphology in a long transverse section of a stress corroded 7075-T651 specimen. $M = 10,700$.

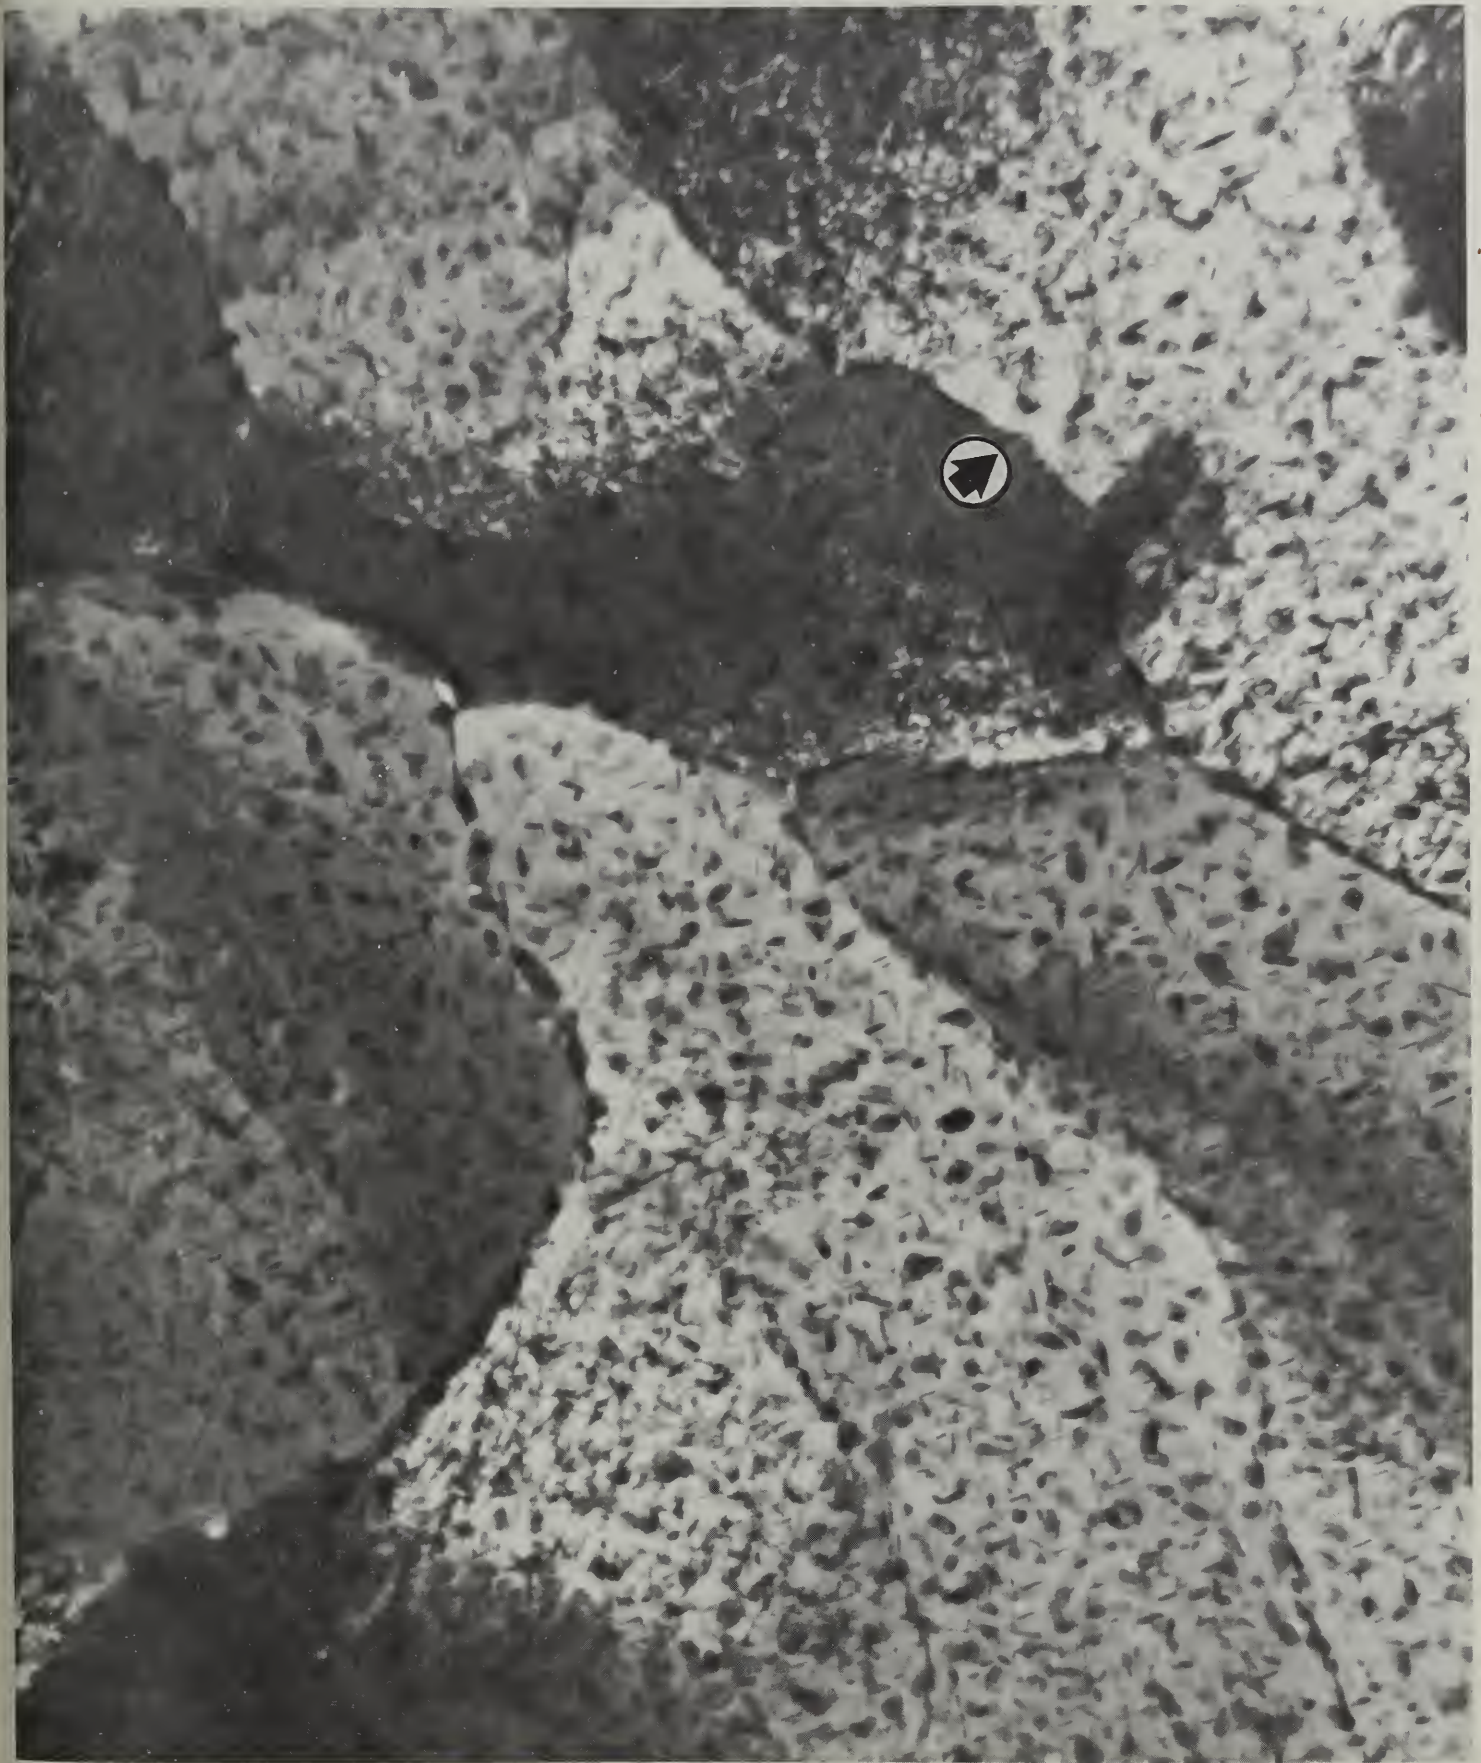
FIGURE 49

Longitudinal section of a 7075-T651 specimen illustrating precipitate distribution. $M = 30,000$.

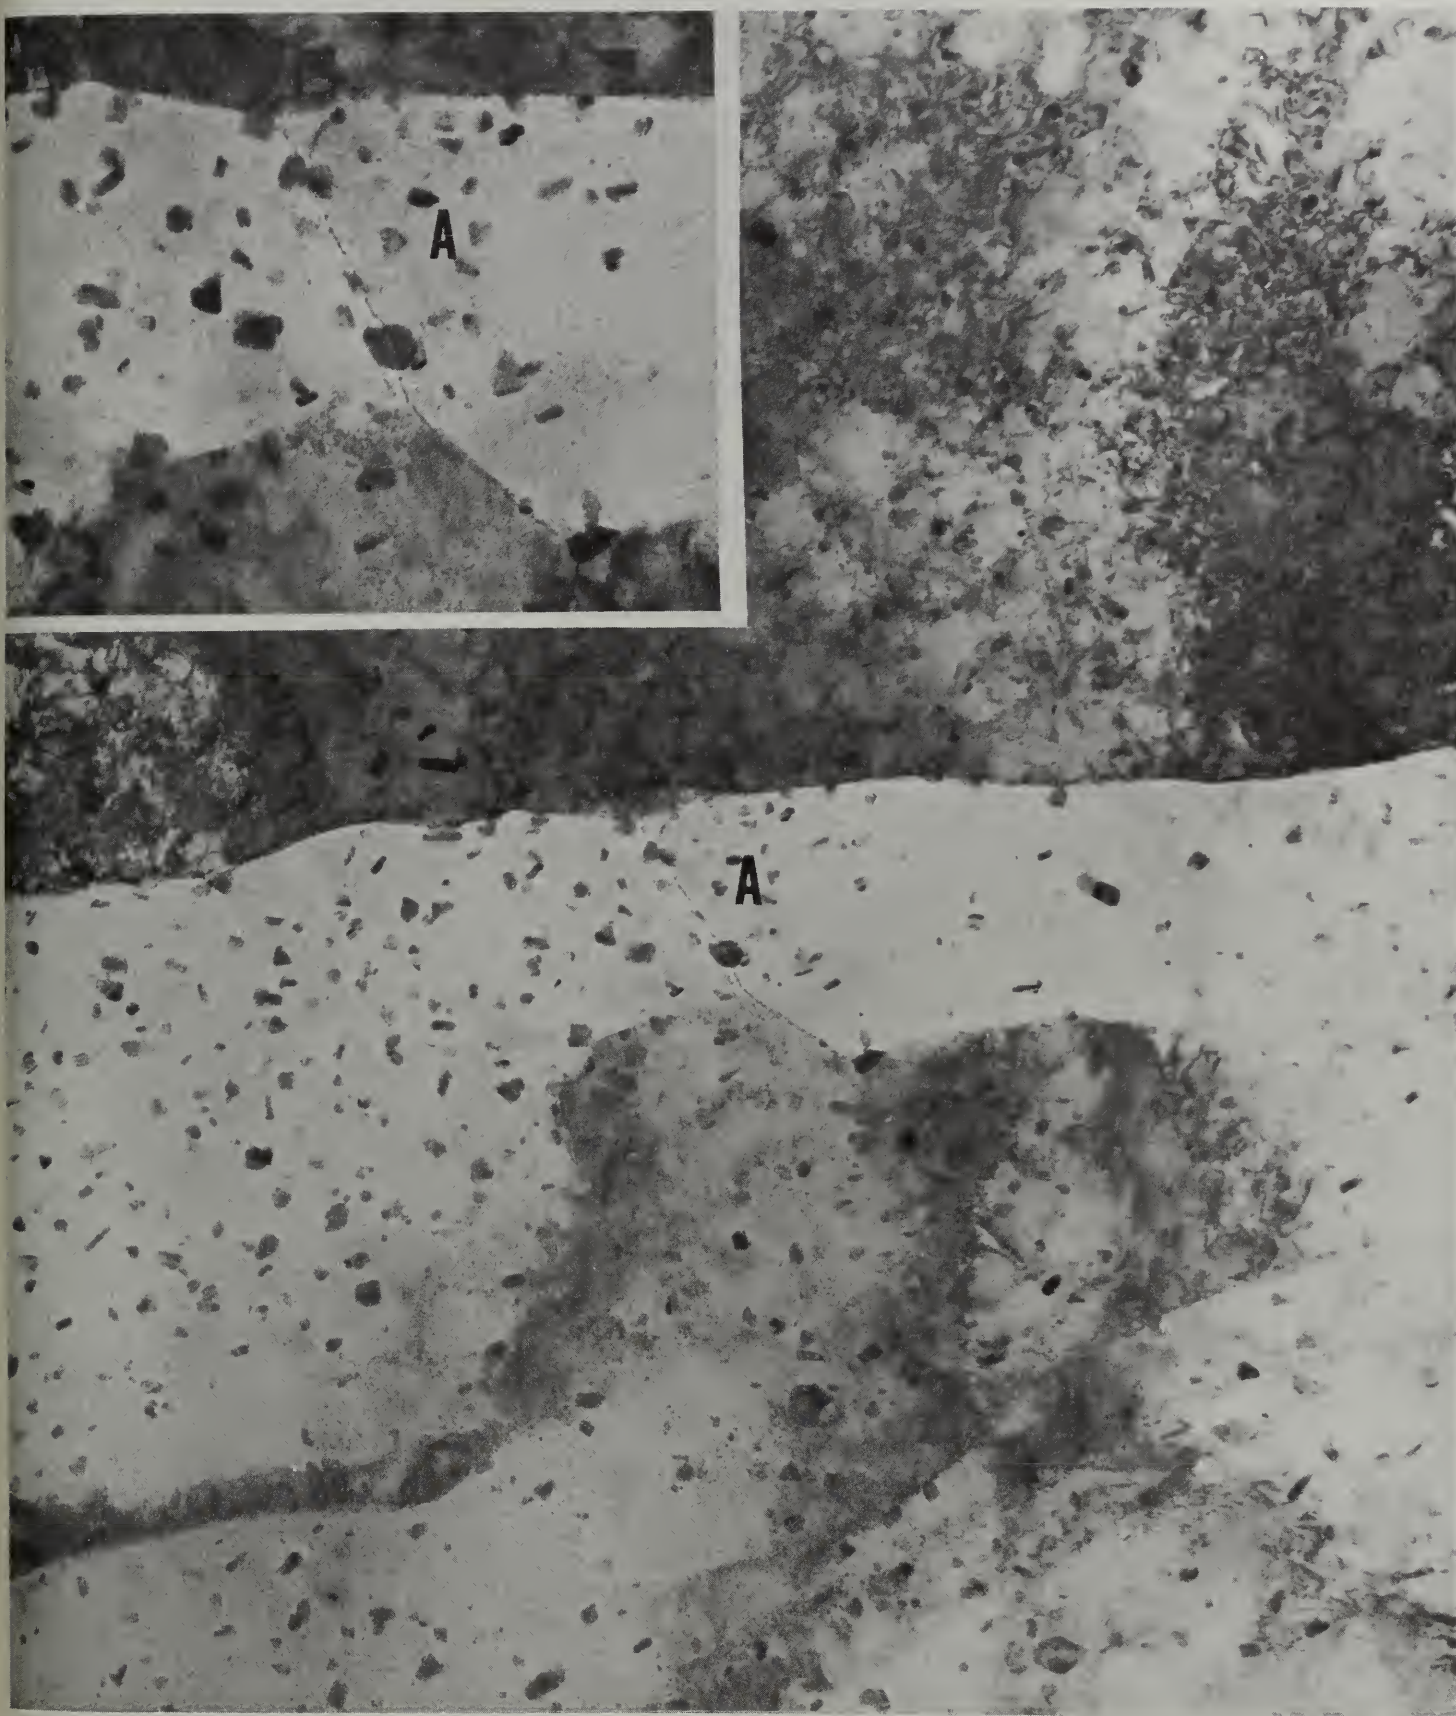
FIGURE 50

A long transverse section of a 7075-T651 specimen.
M = 34,000. The inset shows the area of a low
angle transverse boundary at M = 51,600.

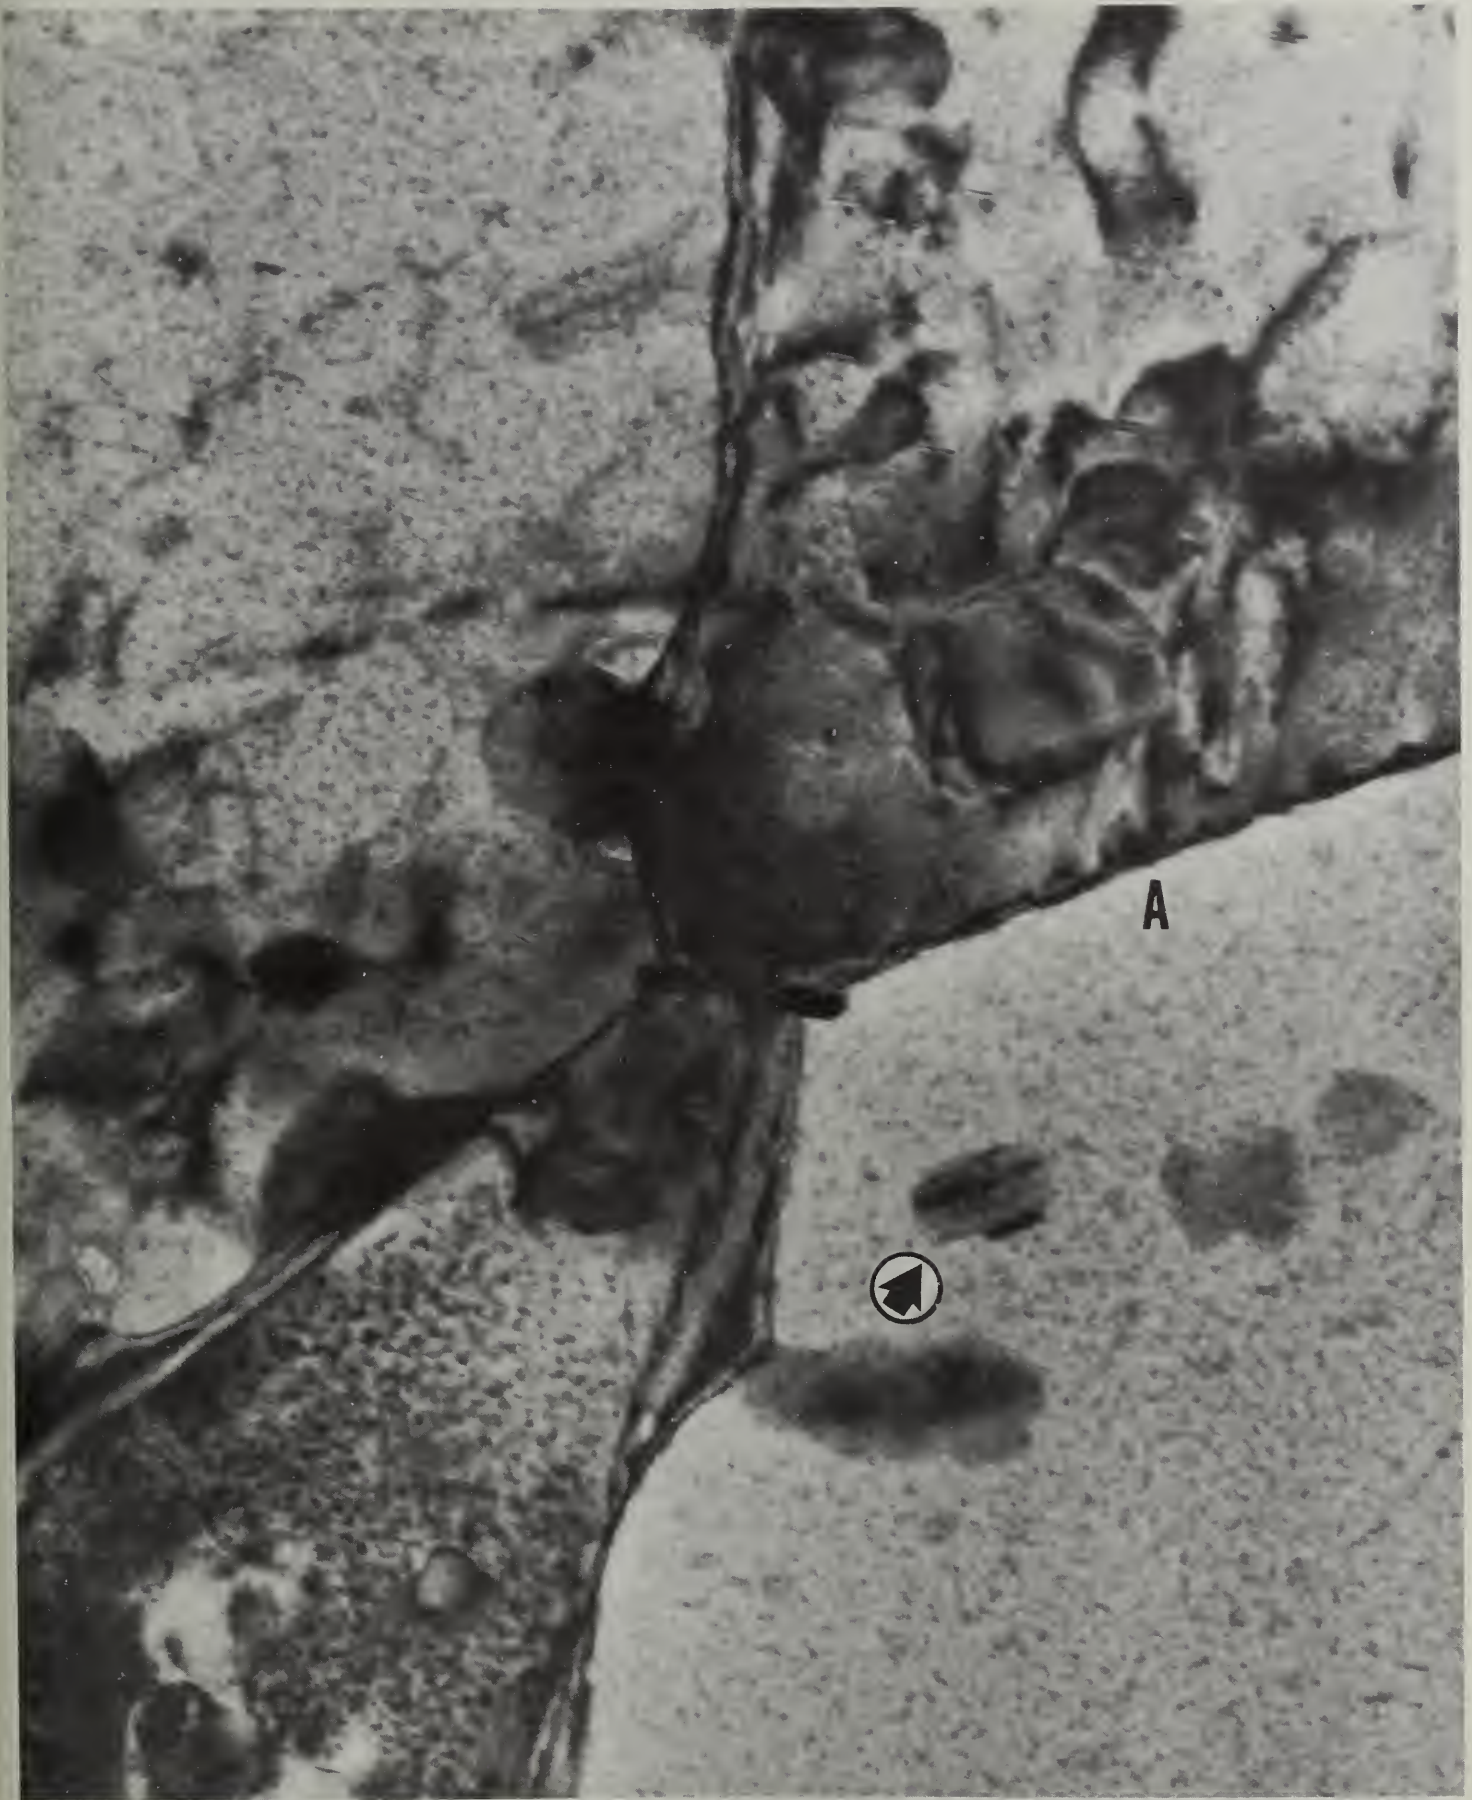
FIGURE 51a

Grain boundary and precipitate structures in the long transverse section of 7075-T651. $M = 268,000$.

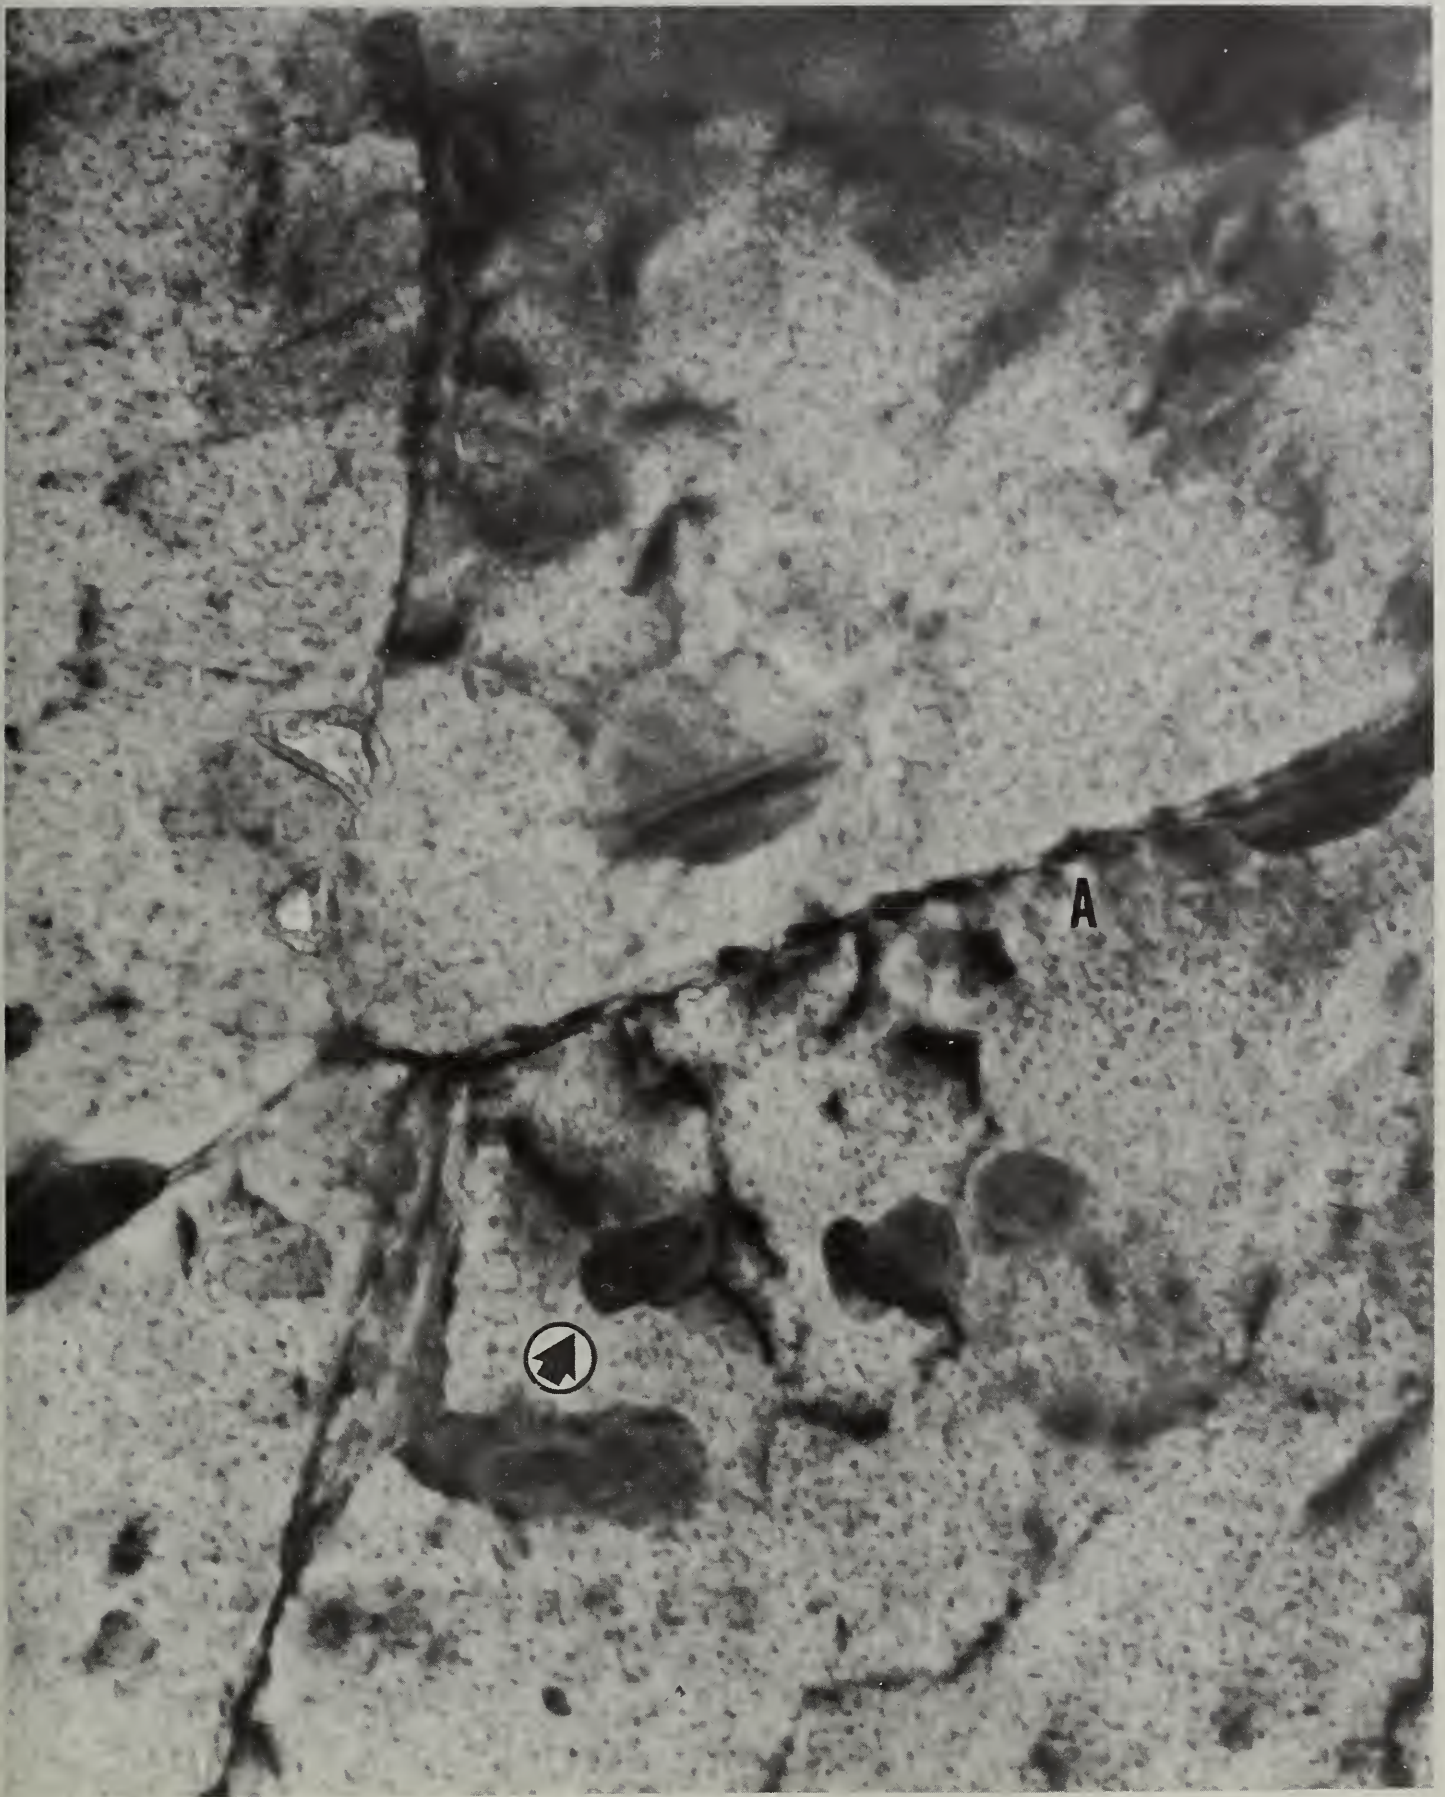
FIGURE 51b

Area of 51a tilted to show dislocation contrast.
M = 268,000.

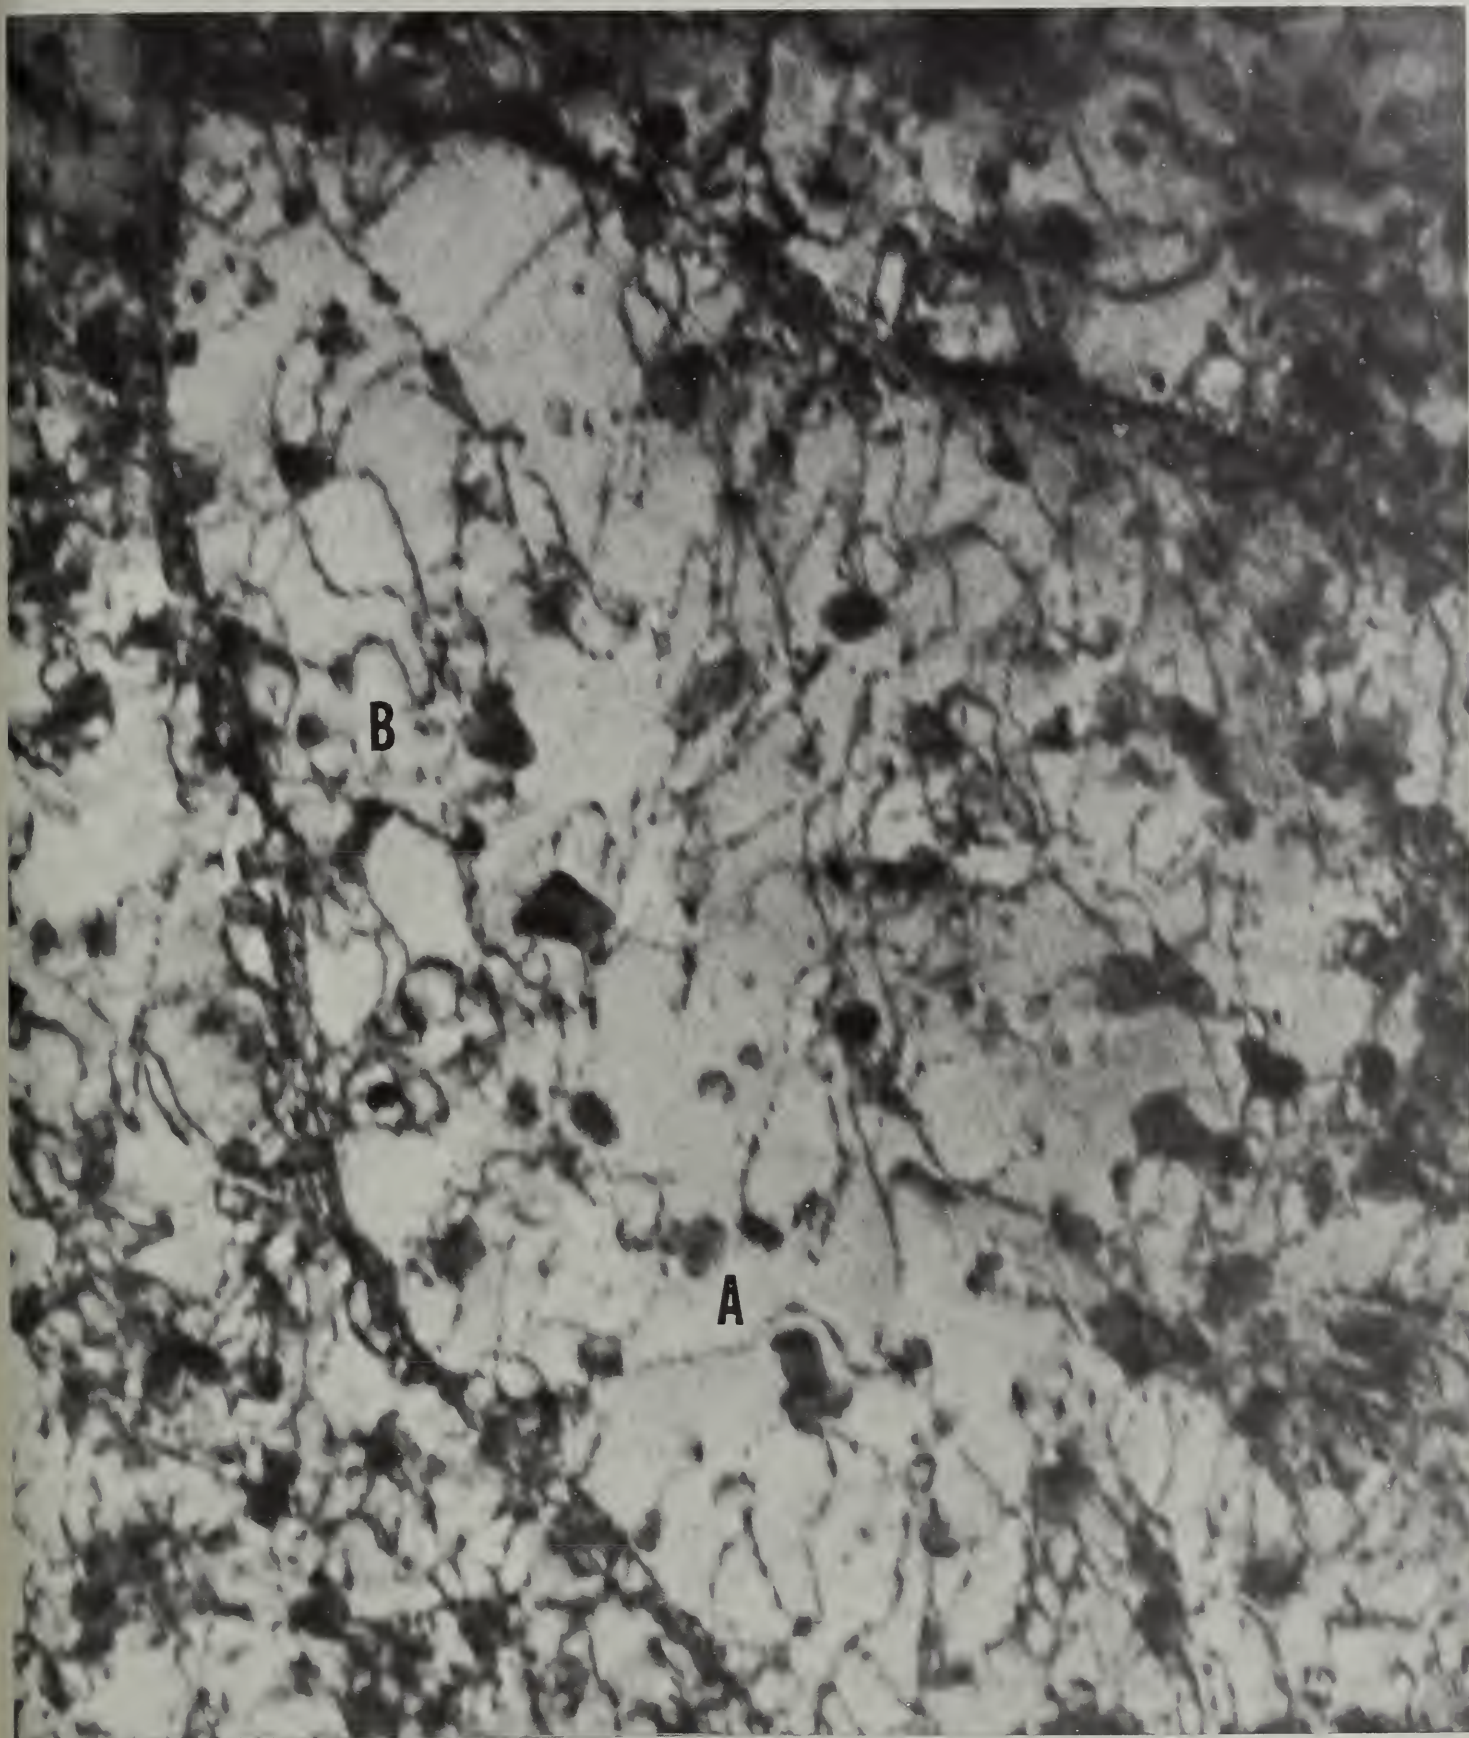
FIGURE 52

Dislocation and precipitate interactions in a long transverse section of 7075-T651. $M = 92,000$.
